## Proposed Ecological Restoration Projects

### 4.1 Development of Conceptual Habitat Restoration Projects

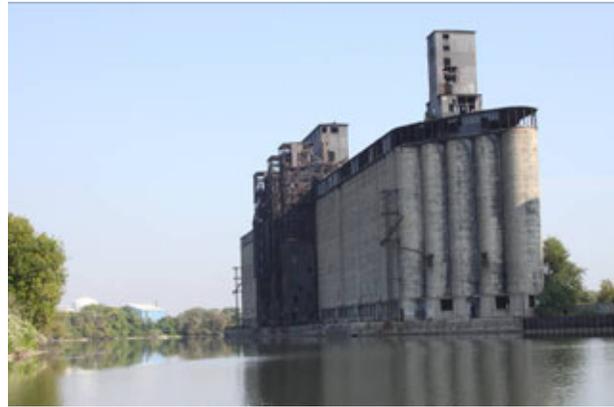
**Photo 4.1-1 Abandoned Grain Elevators and modified stream banks within navigation channel**

The landscape adjacent to the waterways within the ERMP focus area includes a mosaic of natural features, highly modified urban land, utility corridors, commercial and industrial facilities, urban infrastructure, parkland, agriculture, and private/residential lands (see Photo 4.1-1). Candidate project locations were assessed with respect to the current physical and ecological attributes and impairments in the context of their landscape position, adjacent land uses, and conditions upstream and downstream of each site.

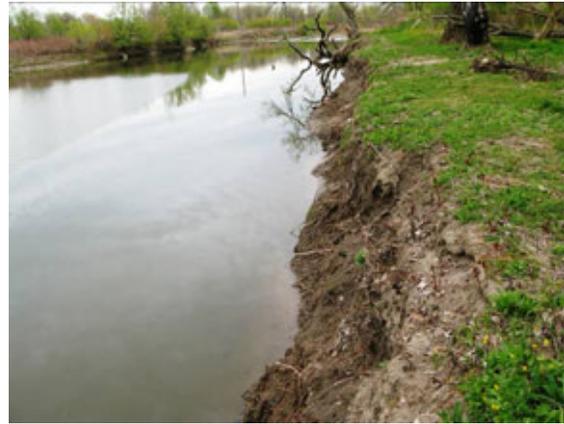
**Photo 4.1-3 Seneca Bluffs lower terrace bank failure with invasive plant understory (Japanese Knotweed and Lesser Celandine)**

Sites were assessed based on the severity of existing ecological impairments and the potential to improve ecological functions through restoration measures that address one or more BUIs. Conditions that stress the biological and physical elements of the sites (see Photo 4.1-3) were identified in the following critical habitat zones:

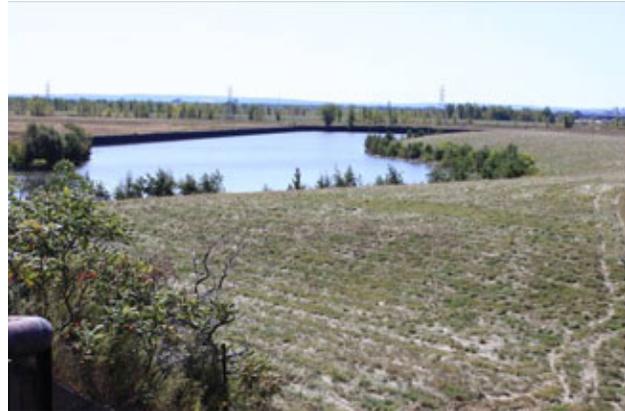
**Photo 4.1-4** Inland and upland area in Urban Brownfield, lower Buffalo River

- **Inland and Upland** – The area extending away from the stream channel and top of stream bank (see Photo 4.1-4); may contain floodplain, wetland, upland, or a combination of these habitats. Provides habitat for terrestrial and wetland species. Cover can be quite variable, including mature canopy tree cover, invasive species, fill and debris piles, active park land, etc. When well vegetated, can establish habitat connectivity between areas by providing wildlife movement corridors.

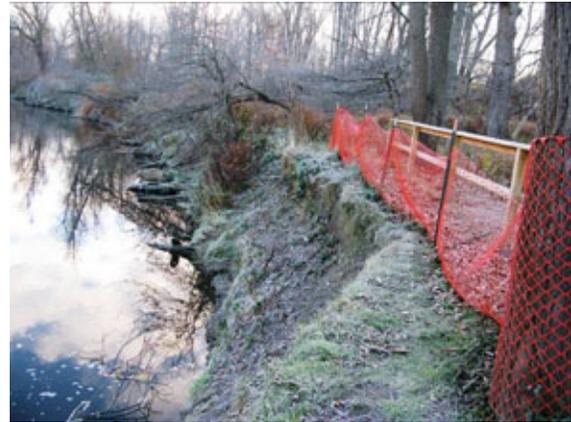
**Photo 4.1-5 Stiglmeier Park bank failure, sediment loading, and loss of riparian habitat**

The conceptual design features provided for each site presented in Section 4.2 have been selected to address observed impairments (e.g., stream bank failures - see Photo 4.1-5) within the affected habitat zones for the purpose of restoring and/or enhancing ecological function. Potential project stakeholders need to rec-

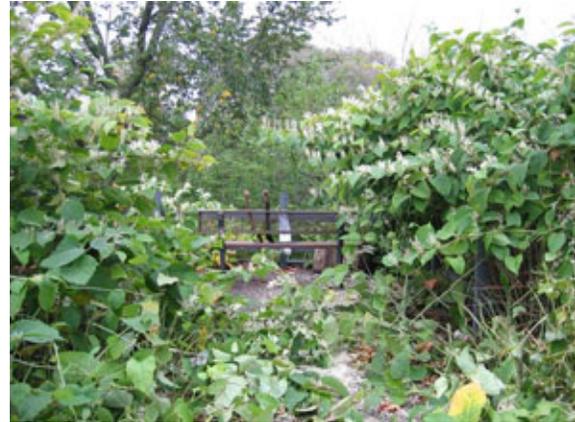
**Photo 4.1-6 Japanese knotweed-dominated riparian area and public access at Bailey Woods**

Invasive species warrant special attention due to the threats they pose to ecological integrity and their role in exacerbating riverine and riparian impairments (see

Photo 4.1-6). The presence of invasive species is common to all sites and degrades riparian habitat by crowding out native species that contribute important habitat functions. Expanding areas of single or multiple invasive species negatively affect each site. Invasive species severely impair wildlife habitat on all sites, with substantial modifications in cover, structure, and available forage. They also can contribute to the physical degradation of the sites by shading out native species that better protect the soil and stream banks. The most prevalent invasive species observed include:

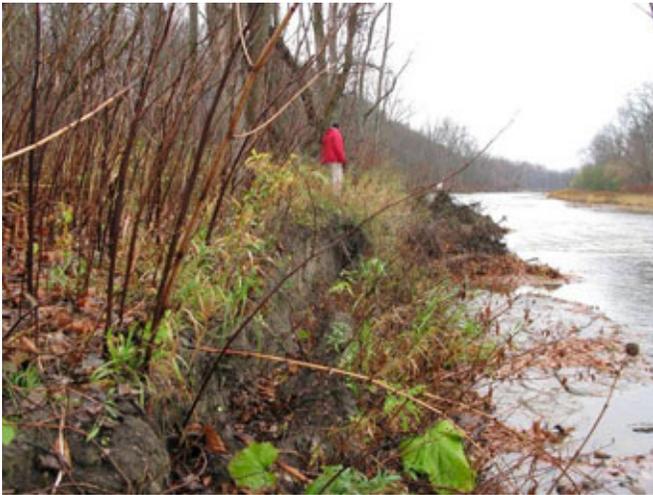
**Photo 4.1-7 Bank failure on West Seneca Developmental Center site along Cazenovia Creek with Japanese knotweed riparian understory**

A majority of the sites exhibit extensive stream bank erosion, which contributes to degraded water quality, and negative impacts on: fishery, benthic, and riparian habitats. Stream bank erosion and bank failures, and subsequent sediment loading, are directly linked to the prevalence of invasive plant communities. Invasive plant monocultures such as Japanese knotweed provide minimal soil stabilization and expose surface soils to erosion by eliminating native vegetation layers. Bank failures were evident on sites where invasive plant communities exist along stream banks and inland riparian areas (see Photo 4.1-7). Many inside channel bends, which are not normally susceptible to erosion from scouring flows, were failing due to unstable stream bank soils.
