### **4.3 Prioritizing the Selected Habitat Restoration Projects**

## 4 Proposed Ecological Restoration Projects

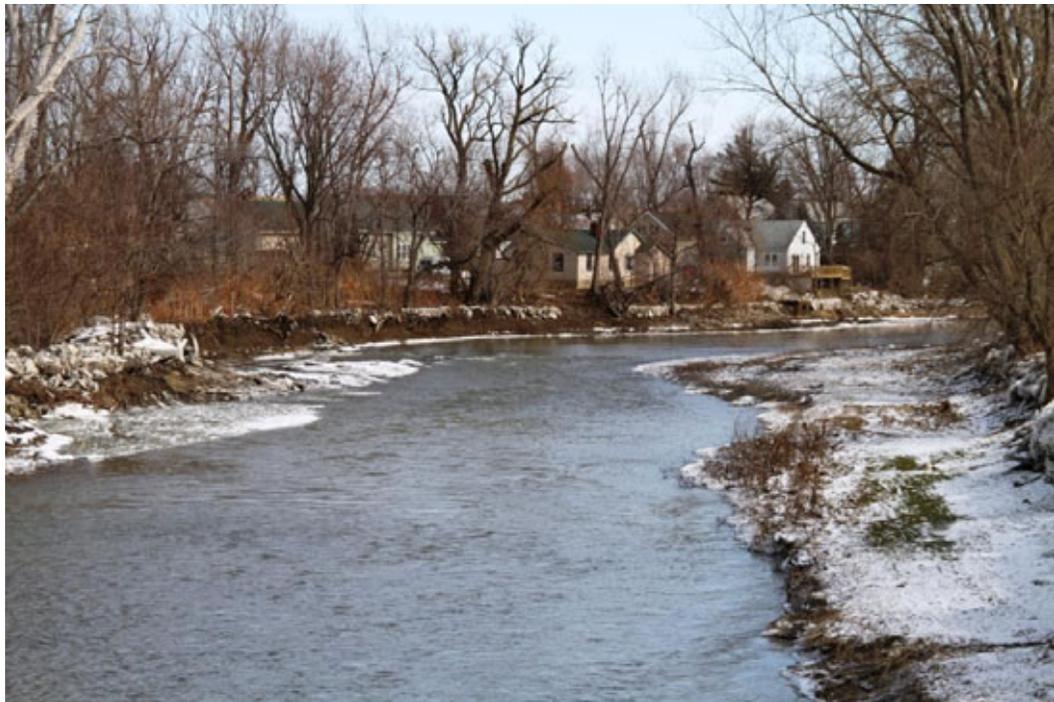
**Photo 4.3-1 Cazenovia Park site continual bank failure, observed on February 21, 2011**

The sites selected for development of ecological restoration projects exhibit significant, urgent problems that warrant consideration for action in the near future. Field observations conducted prior to 2010 and then later during ERMP field assessments have confirmed the occurrence of extensive stream bank instability, which has resulted in substantial loss of stream bank and riparian vegetation throughout the ERMP focus area. For example, after two combined flood stage and ice out events in early and late February 2011, field observations at some sites suggest that significant stream bank and floodplain soil losses have occurred since the ERMP field assessments were completed in the fall of 2010. Additionally, based on qualitative observations in March of 2011, Seneca Bluffs, Cazenovia Park, and Stiglmeier Park exhibited stream bank losses of approximately 3 to 5 feet from early November 2010 to March 2011 across hundreds of linear feet of stream bank (cumulatively). Land is being lost and the river/creek channels are becoming wider due to undercutting and subsequent collapse of soil and vegetation into the river/stream channel. Review of aerial imagery suggests that soil loss (and therefore riparian loss) on these sites has been accelerating.

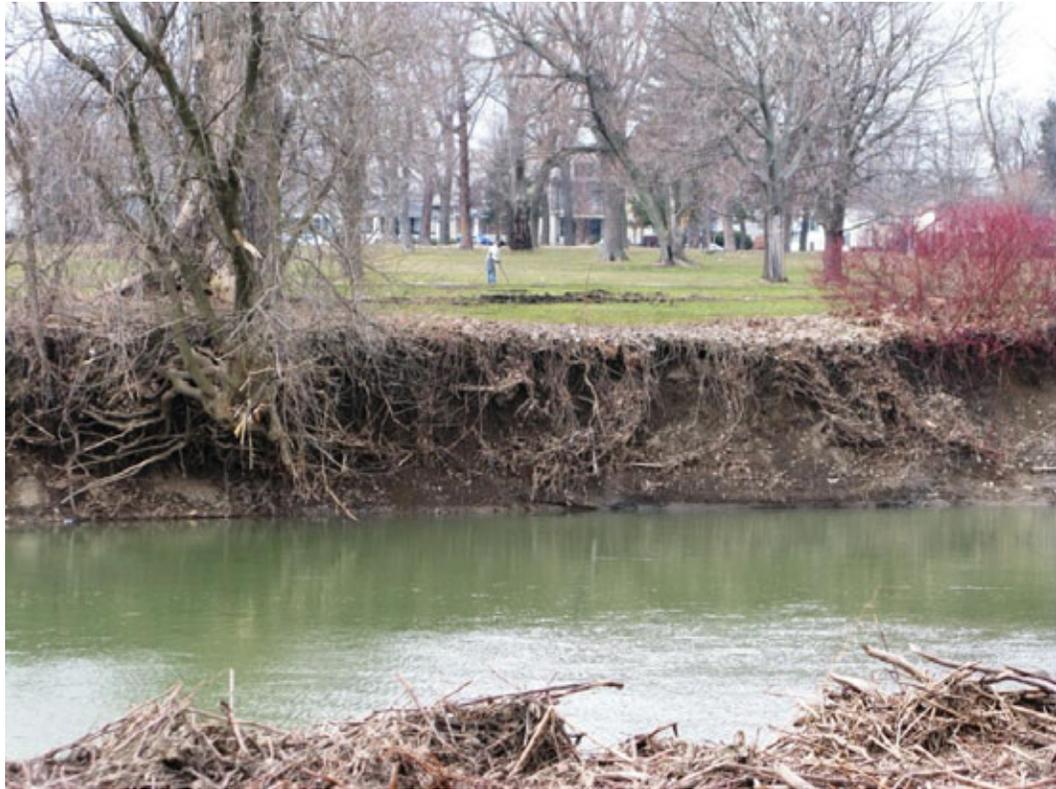
**Photo 4.3-2 Cazenovia Park LDB undercutting and failure at Golf Course, observed on April 3, 2011**

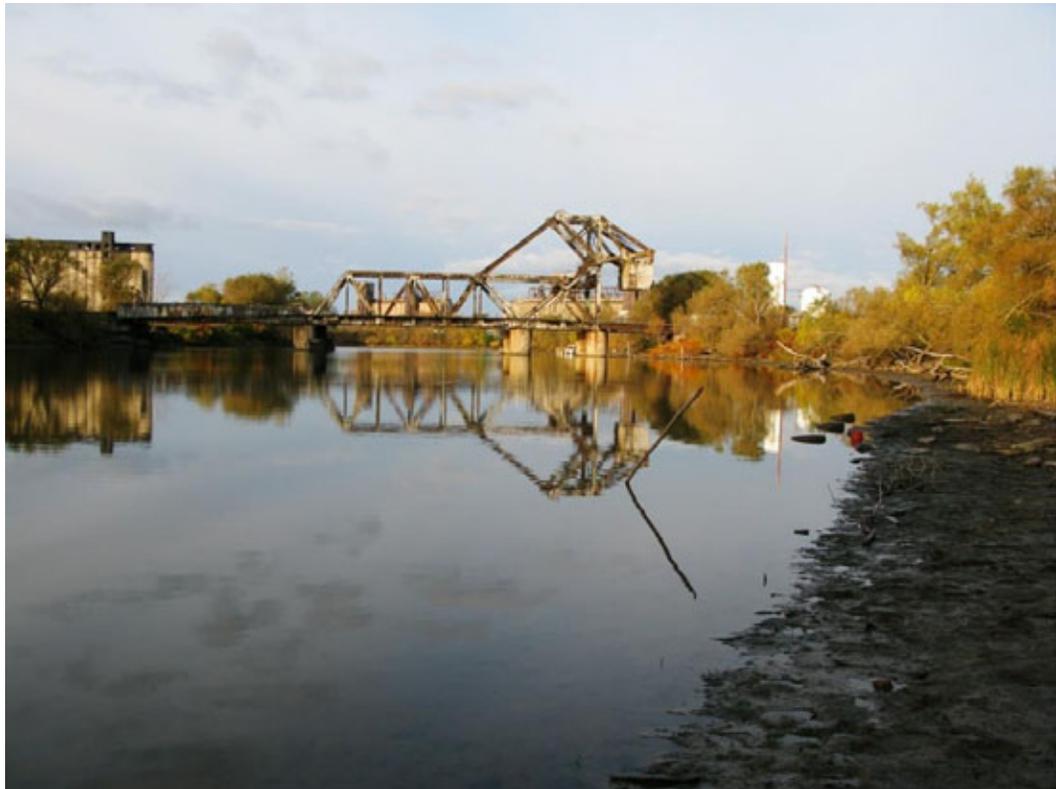
**Photo 4.3-3 Remedial dredging along Smith Street Park shoreline**

These four sites are also near the federal navigation channel limits and the vicinity of the Buffalo River Habitat Restoration Project. The work planned under this GLLA project includes removal of contaminated sediment by dredging followed by restoration of natural habitat and structural features to support regeneration of native plant communities. Dredging of the navigation channel will begin in 2011 with stream bank stabilization and restoration activities to follow.
